PARTIAL RECOVERY AND RECONSTRUCTION AFTER DISASTER: THE LICE CASE*

William A. Mitchell

Department of Economics, Geography and Management, United States Air Force Academy, Colorado

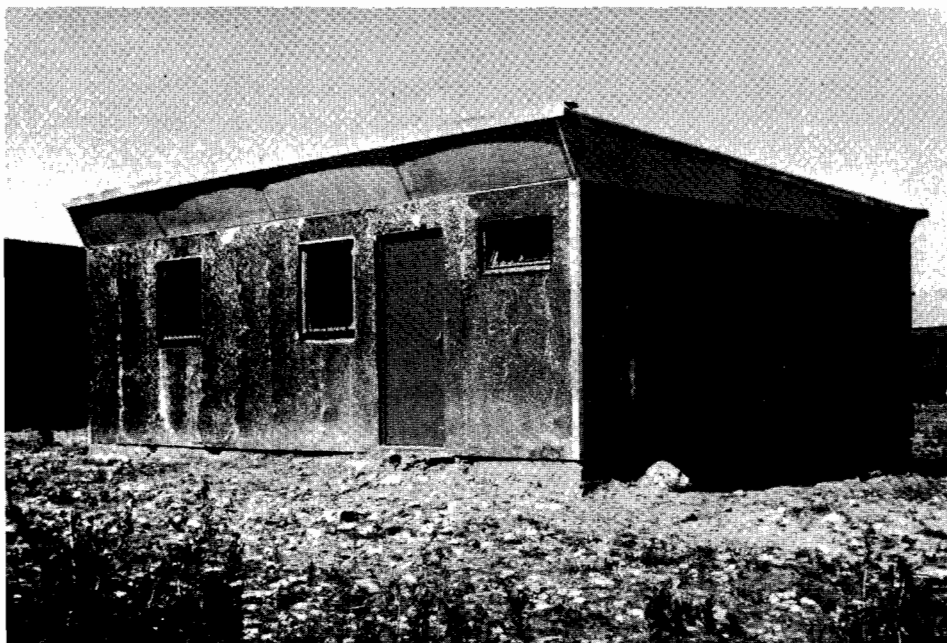
Fig. 3. French style prefabricated house.

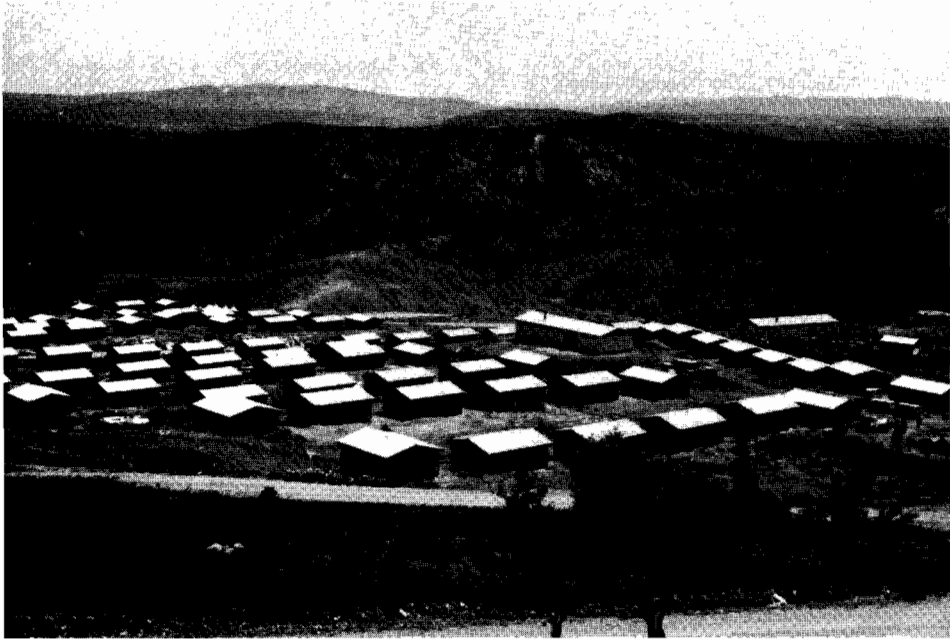
Fig. 4. Settlement of German style houses.

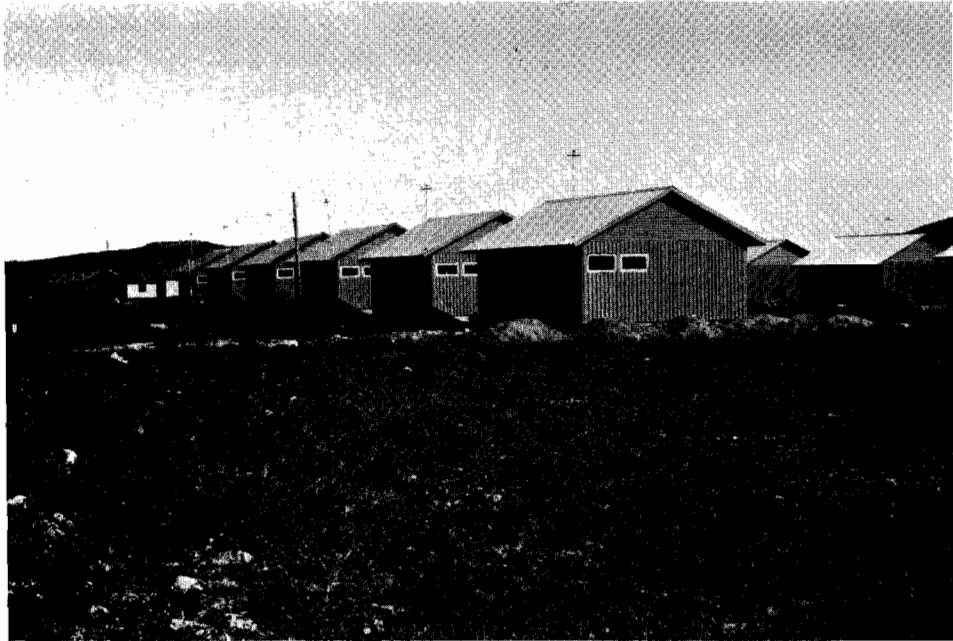
Fig. 5. Settlement of Yugoslavian style houses.

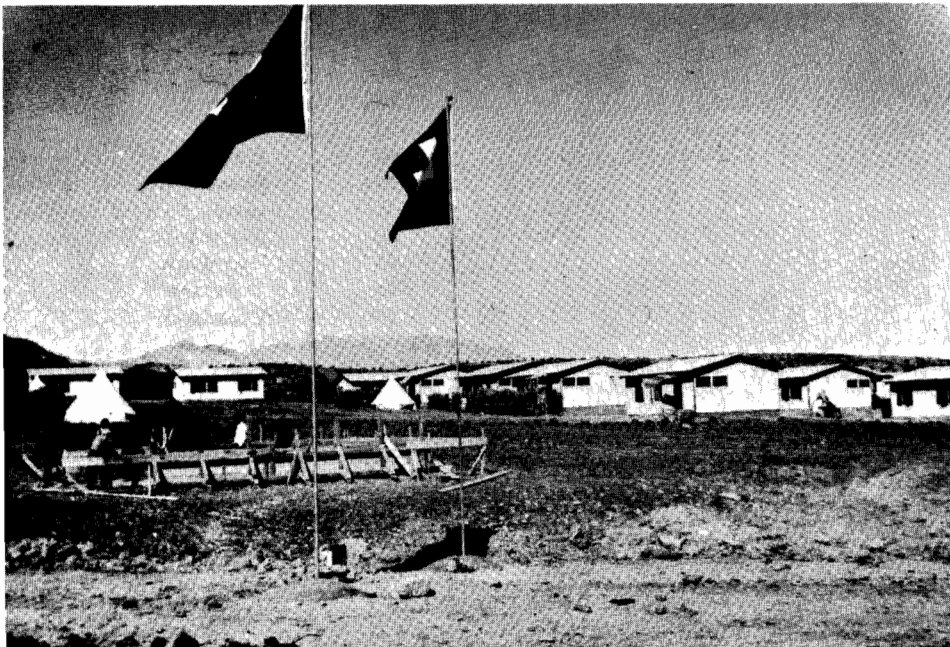
Fig. 6. Yünlüce: Swiss style houses.

Yünlüce village is now very distinctive compared to other restored settlements (Fig. 6). The Swiss Disaster Relief Organization of the Swiss government, in cooperation with the Republic of Turkey, selected Yünlüce for rebuilding as a model "Swiss" village. A Swiss survey team visited the disaster area from 29 September to 4 October 1975 and selected the

The new white colored homes with brown Swiss window shutters and bright green colored sheet steel roofs make a remarkable contrast with the traditional adobe house. Unfortunately, it is doubtful that Yünlüce will have electricity in the foreseeable future. The expenses to the Swiss government for materials, labor, and transportation for the 50 houses was 966,500 Swiss francs [12].
